ILC 1X1 – CHANGE NOTES

Change notes for ILC 1X1 Inline controllers

Application note
105625_en_07

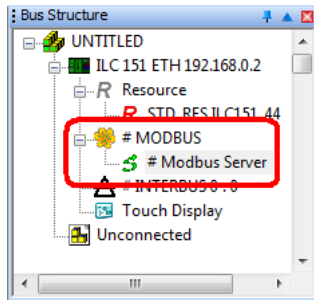
Type ILC 1X1 controllers can now also be configured as Modbus/TCP servers.

Figure 1 Modbus/TCP servers in the PC Worx Bus Structure

Each controller supports a different number of communication connections to the Modbus/TCP clients:

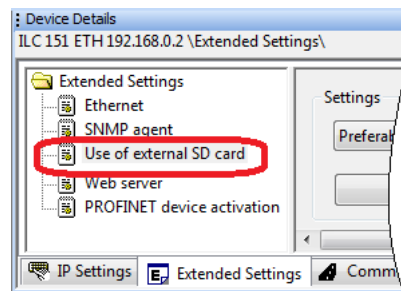
You can select the SD card functions you need in the "Device Details" window in PC Worx.

Figure 2 Selecting SD card functions

The SD card's functionality has been extended. The SD card can now be used either as the main memory or as additional memory.

As additional memory, the SD card can be used for storing log files.
